Re: Great Northwest Railroad, Inc. – Abandonment Exemption – In Clearwater  
County, Idaho  
STB Docket No. AB-872X

STATE OF IDAHO'S COMMENTS ON  
ENVIRONMENTAL ASSESSMENT

WATERSHED ASSESSMENT AND MASTER PLAN FOR  
FLOOD MITIGATION AND STREAM RESTORATION ON  
LOWER OROFINO CREEK

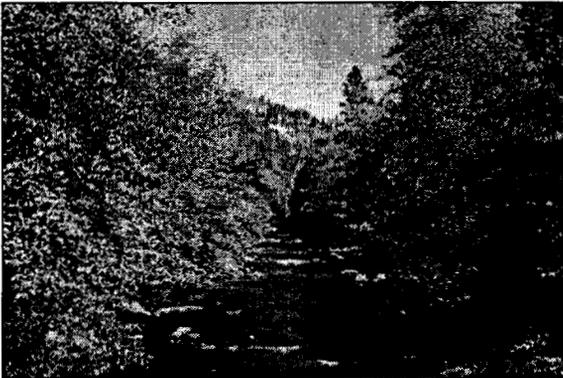
***Photograph 2.1***

*Typical conditions in Reach 1. Evidence of past channelization can be observed by the unnatural straightness of the creek.*

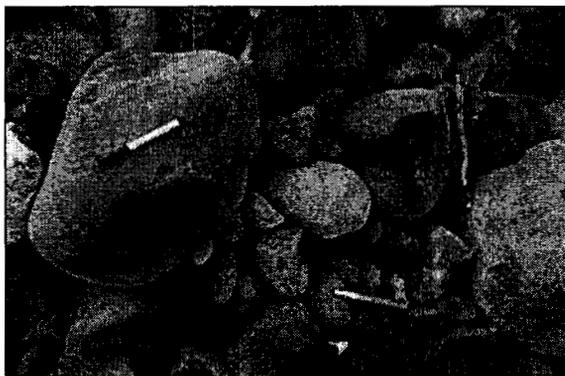
**Photograph 4.1:**

*Typical sediment  
deposits in Orofino  
Creek*

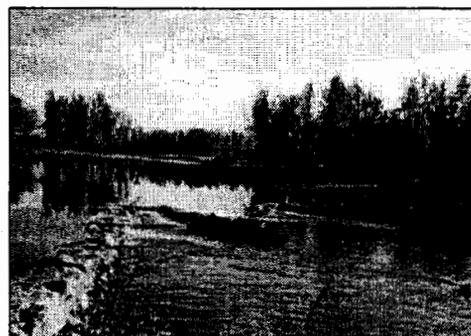
**Photograph 4.4:** (a) The Konkolville Mill Bridge – note the two in-channel piers. (b) An example of a W-weir that could be constructed to mitigate scour.

Ideally, bridge piers should be located outside of the bankfull channel. Since modifications to the bridge structures are not part of the scope of this project, other alternatives were explored. To mitigate the possible effects of pier scour, hydraulic structures such as W-weirs are recommended. W-weirs are designed to split the flow around a pier thus creating an area of lower shear stress and reduced scour at the pier. Moreover, W-weirs provide grade control and habitat complexity.

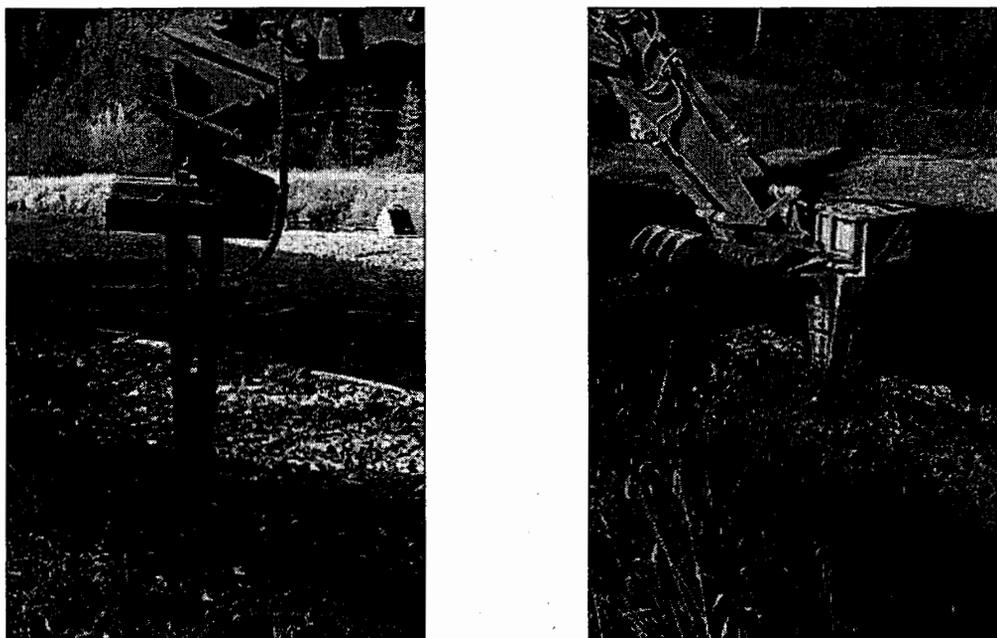
*Photograph 5.1 (a) The Stinger revegetation technology. (b) The Rotary Stinger revegetation technology.*

The new technology now makes it possible to plant sites that were previously considered to be “unplantable” by conventional methods. The innovative Stinger and Rotary Stinger technology of Northwest Revegetation and Ecological Restoration (NWRER) can successfully revegetate difficult sites such as riprap and cobble dominated banks and bars. The Stinger is capable of planting a full size range of containerized plants, cuttings and poles through riprap and cobble. The Stinger can plant cuttings and poles to a depth of up to approximately seven (7) feet. This deep planting assures the cutting remain in contact with moist soil even during the driest months which significantly increases their survivability. The Rotary Stinger is best suited for planting rooted plants in cobble and gravel. The rooted plants are propagated in containers having a volume of approximately one gallon. The unique shape of the containers produces a long root system that extends below the roots of most competing vegetation. In addition, the long root system allows the plant to access water and nutrients from deep within the soil. When the containerized plants are inoculated with a diversity of beneficial soil microbes the growth, vigor and sustainability of the plant is significantly improved.

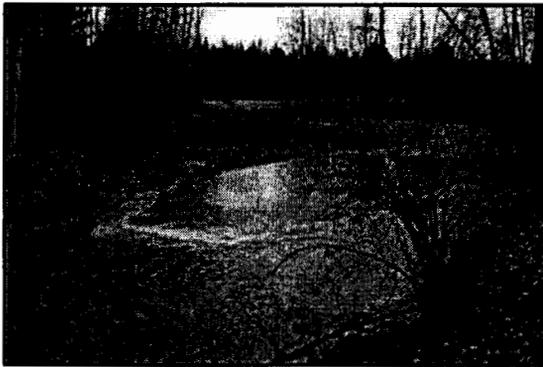
**Photograph 5.2**

*Example of a rock cross vane grade control structure. Refer to Appendix D for structure details.*

Considering the potential B3c stream type of Orofino Creek, rock cross-vanes are proposed for grade control. A typical rock cross-vane is presented in Photograph 5.2 and Appendix D. Cross-vanes direct shear stress away from the stream banks and concentrate it toward the center of the channel thus creating optimal fish habitat in the scour pool below the structure. Cross-vanes include a rock sill at the floodplain elevation that extends laterally across the floodplain perpendicular to the flow to prevent downcutting until adequate vegetation is established. Cross-vanes are specifically designed and constructed to pass bedload and prevent bed aggradation. These structures have no significant effect on base flood elevations or velocities, but provide stabilization of the channel profile at key locations, primarily at the downstream terminus of meanders (at the pool tailout) and also in extended riffle sections.

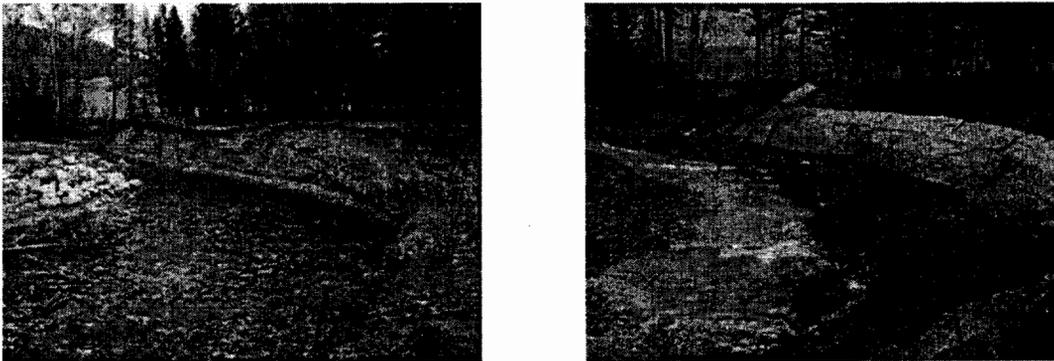
*Photograph 5.5: An example of channel reconstruction using natural channel design techniques (a) before and (b) after construction*

Channel reconstruction involves the realignment of the channel bed along with channel shaping, bank stabilization and revegetation. Channel reconstruction is the best means to restore the river to its historic condition. With channel reconstruction, it is possible to restore the historic meander pattern of a river and adjust the bed elevation so that floodplain connection is regained. Other advantages include improved sediment transport competency, complex and diverse aquatic habitat creation, flood relief and long-term bank stability. Disadvantages to channel reconstruction include extensive disturbance, possible impacts to private property, more extensive permit reviews, and higher design and construction costs than other alternatives.

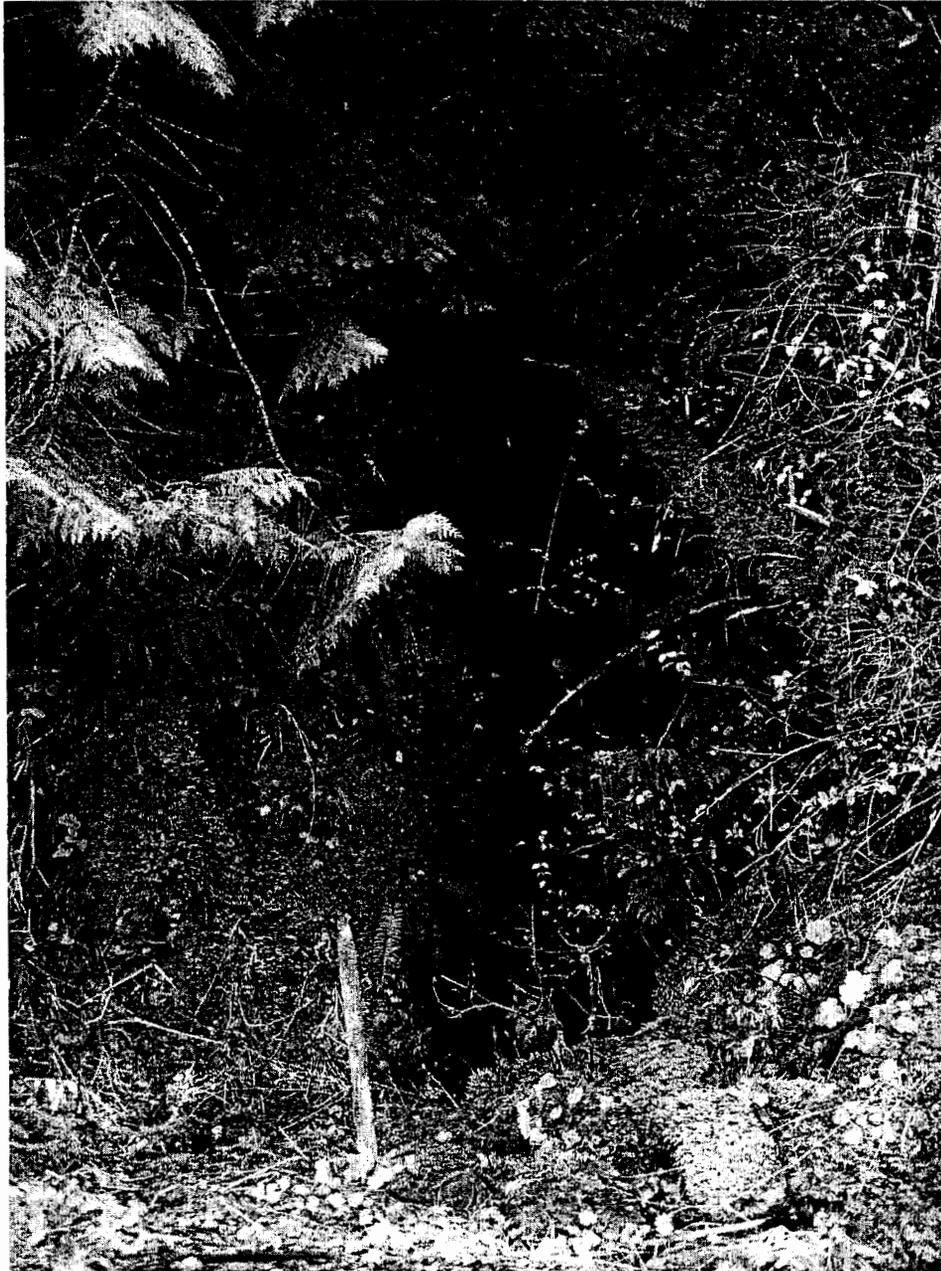
#### CULVERT # 1 INLET

Culvert 36" x 40', Fill Depth approximately 5' ( 4' @ inlet, 6' @ outlet).

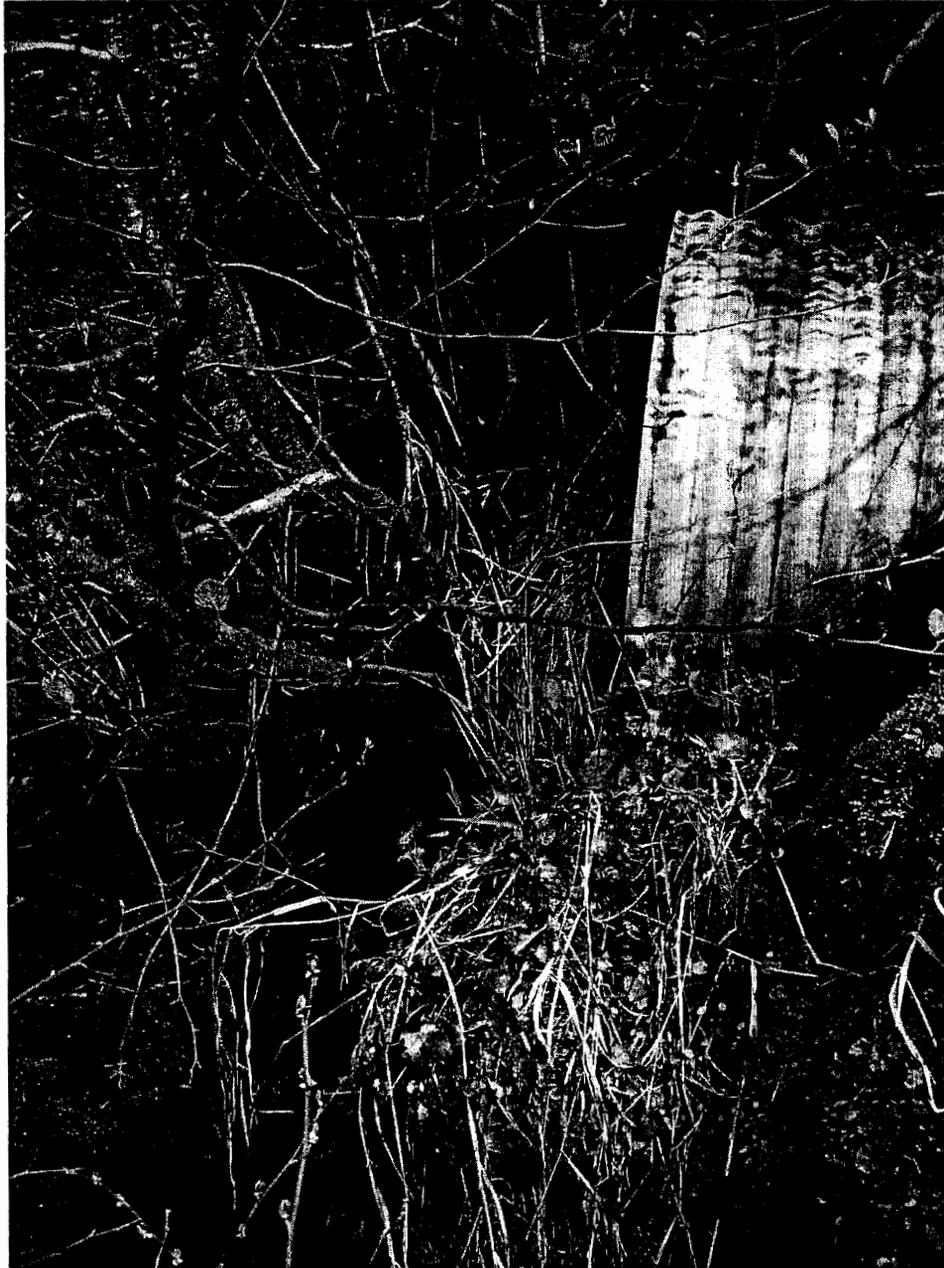
**CULVERT # 1  
(OUTLET)**

**OROFINO CREEK ON LEFT SIDE OF PICTURE**

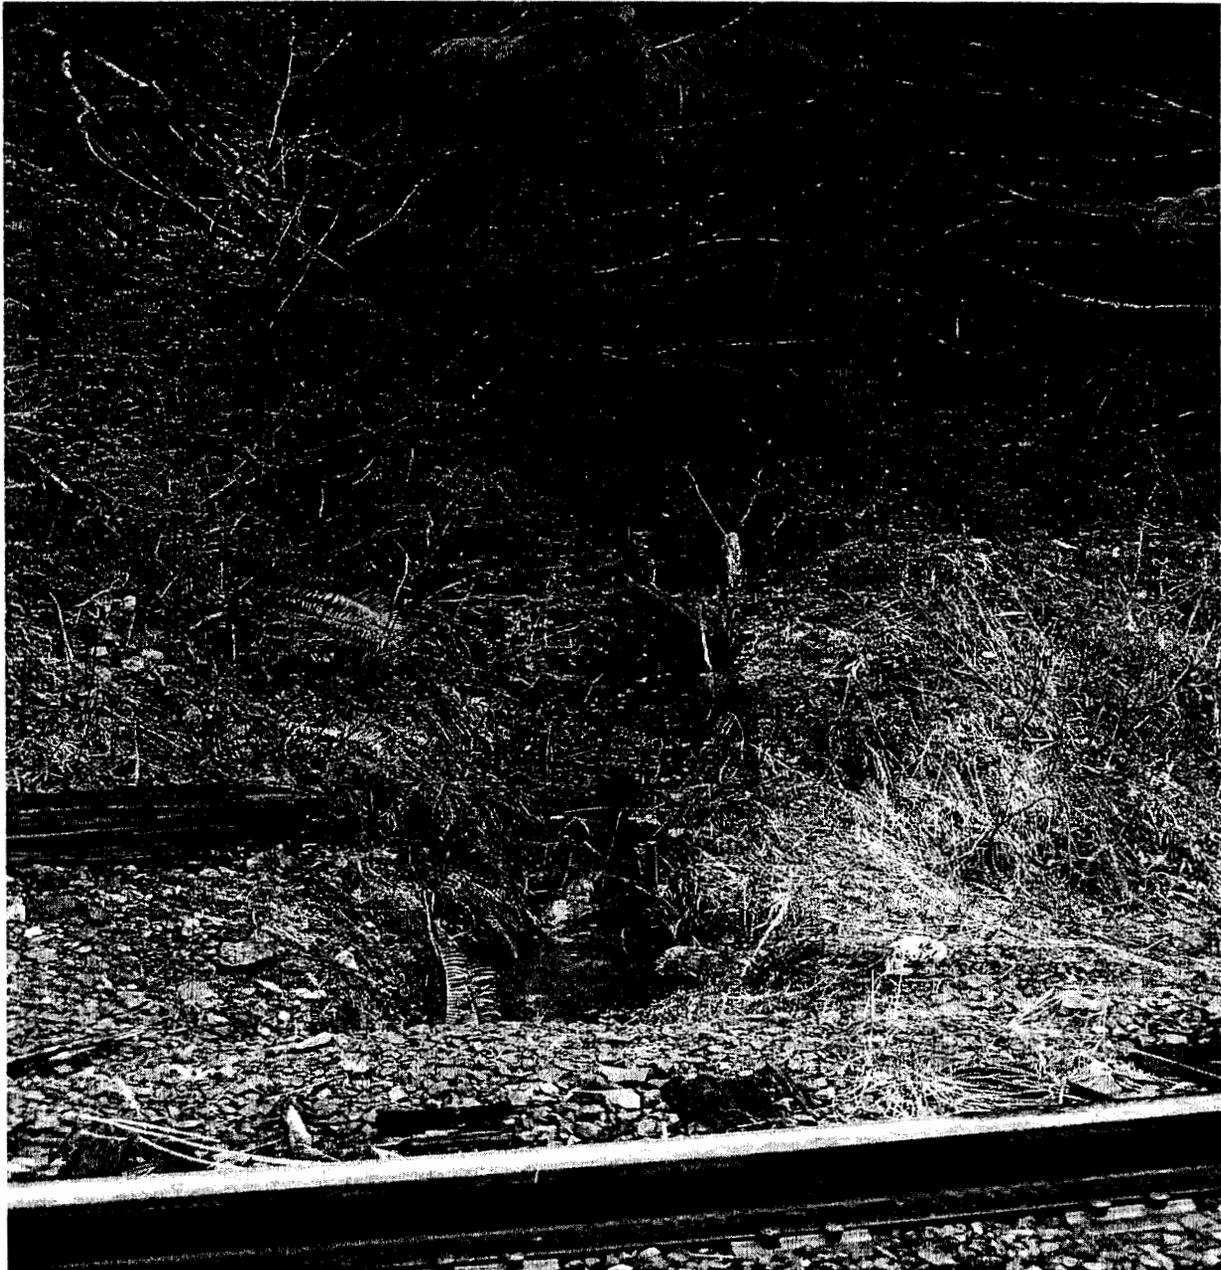
**CULVERT # 2  
WATER SOURCE INTO INLET**

Culvert 24" x 20', Fill Depth approximately 2-3'.  
Live Class II stream tributary to Orofino Creek, 10" wide X 3" deep.

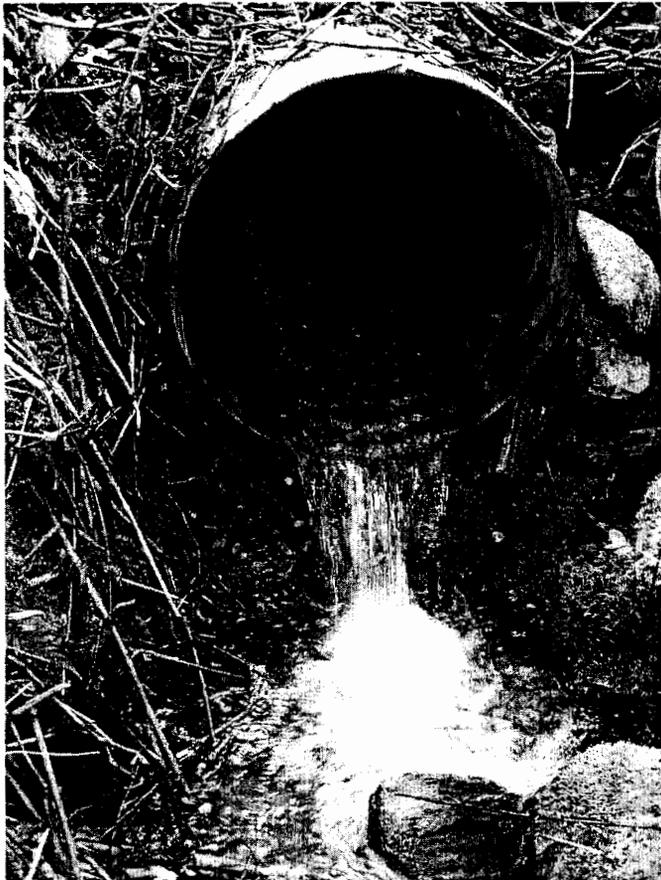
CULVERT # 2

TOP PICTURE-  
CLOSE-UP VIEW OF  
INLET

PICTURE TO RIGHT-  
VIEW OF OUTLET

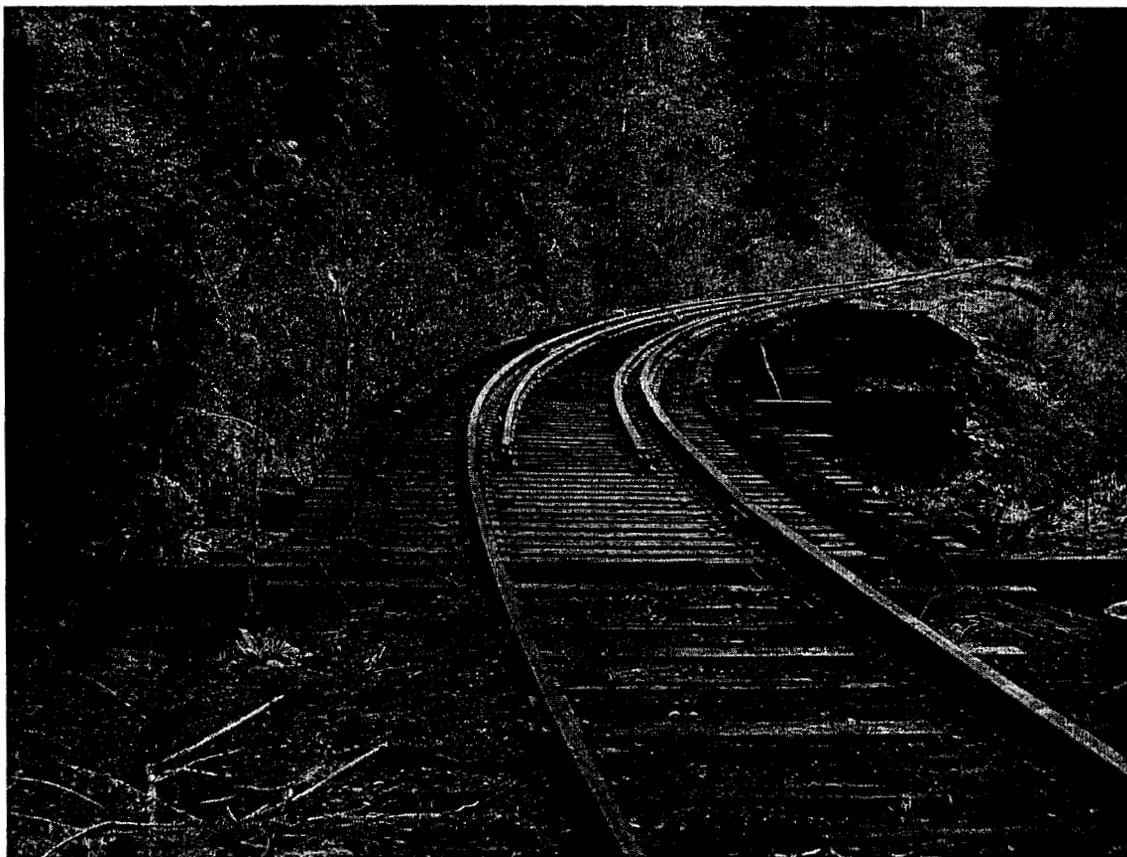
### **Trestle # 11**

Trestle 12.3' wide X 160.9' long, maximum depth to water 16.4'.  
Crosses Orofino Creek, a Class I Stream.

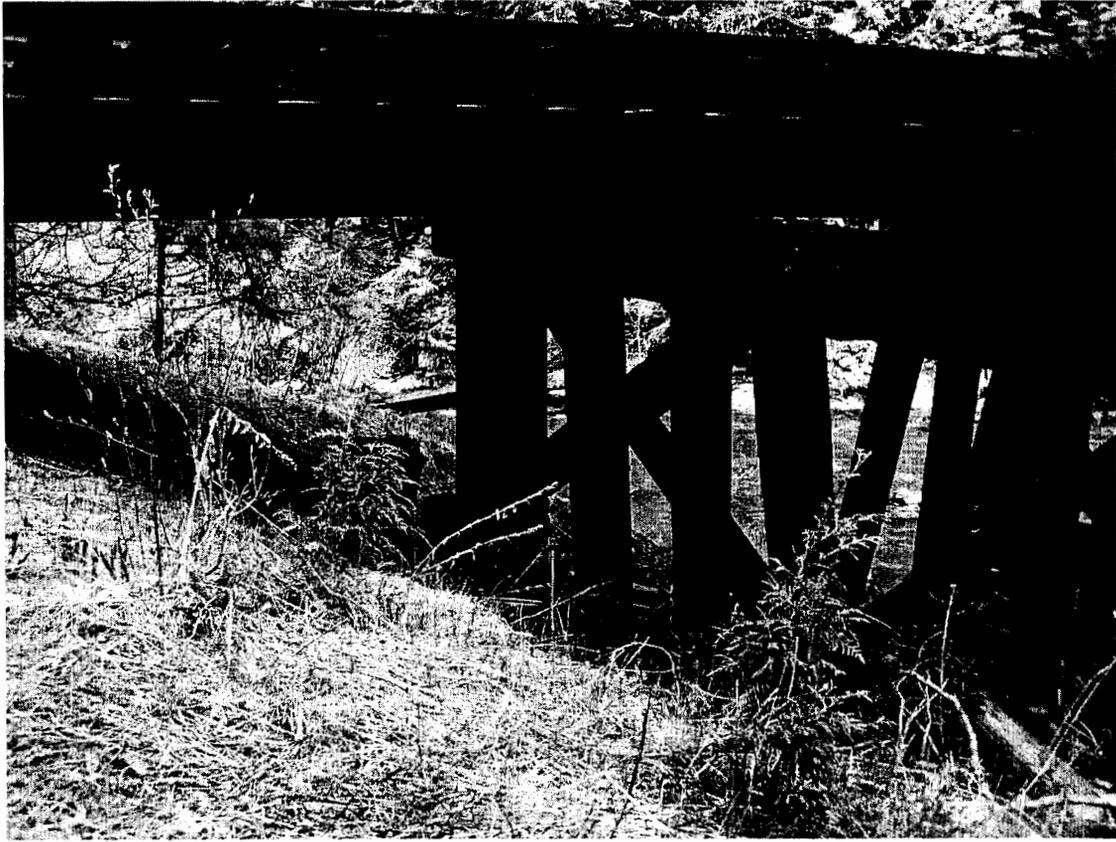
**TYPICAL ROUND PILING CONSTRUCTION**

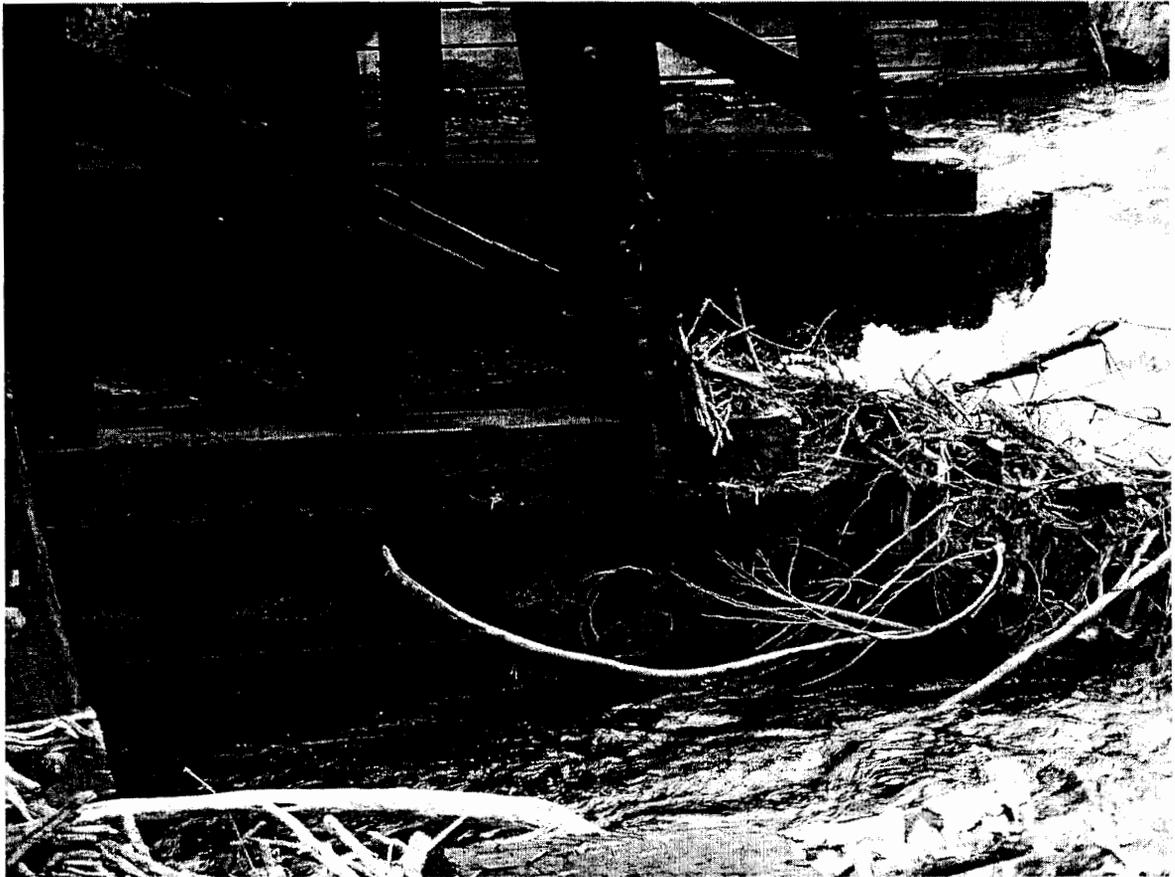
**TYPICAL CEMENT PIER SUPPORT**

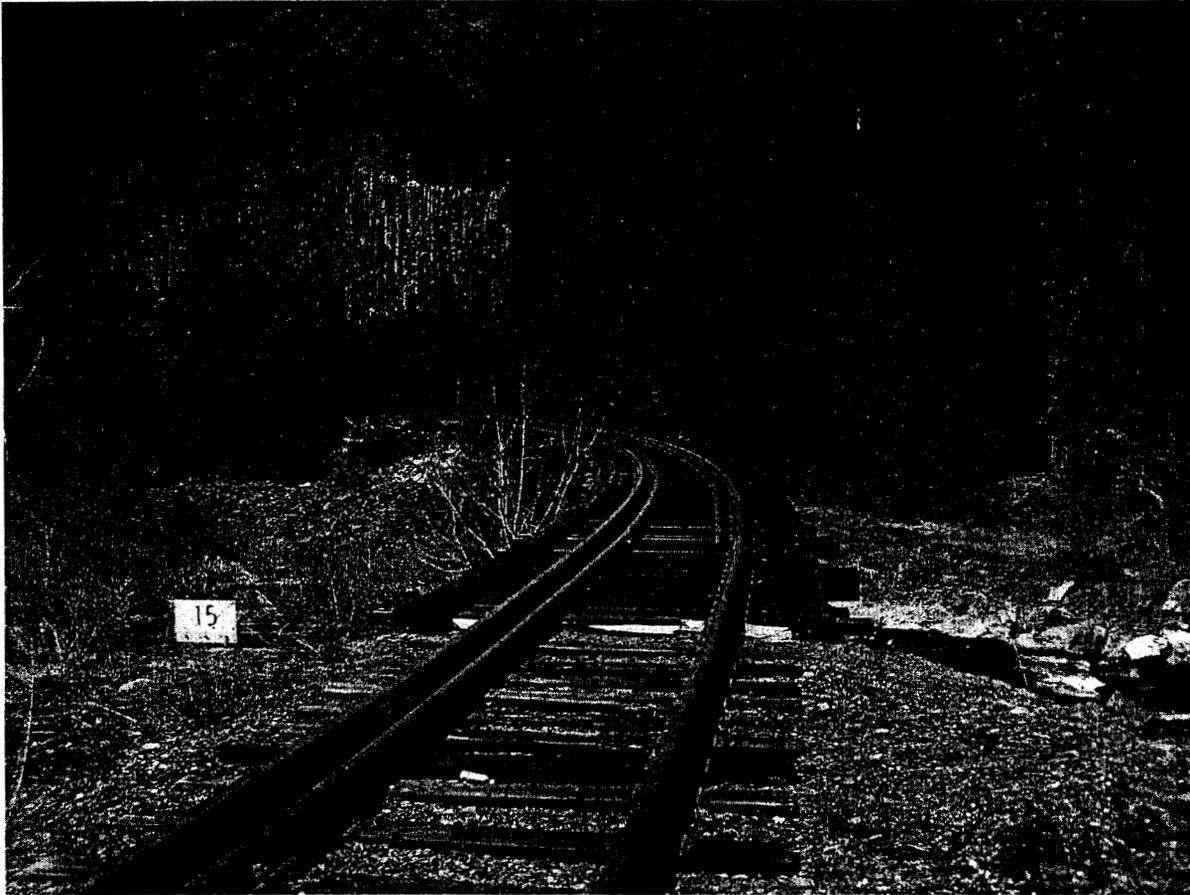
## TRESTLE # 15

PICTURE TAKEN FROM EAST SIDE OF TRESTLE

Piling # 7 has a gabion foundation.

TRESTLE # 15 Trestle 12.3' wide X 226' long, maximum depth to water 24'.  
Crosses Orofino Creek, a Class I stream.  
Abutments 2-3' tall on east end and 3' tall on west end.  
Trestle has 12 piers comprised of six single round post pilings, five double round post  
pilings, and one single piling - listed from west to east.  
Pilings 1-4 are above dry ground, pilings 5-11 are above water, and piling 12 is above dry  
ground.  
Piling # 7 has a gabion foundation.

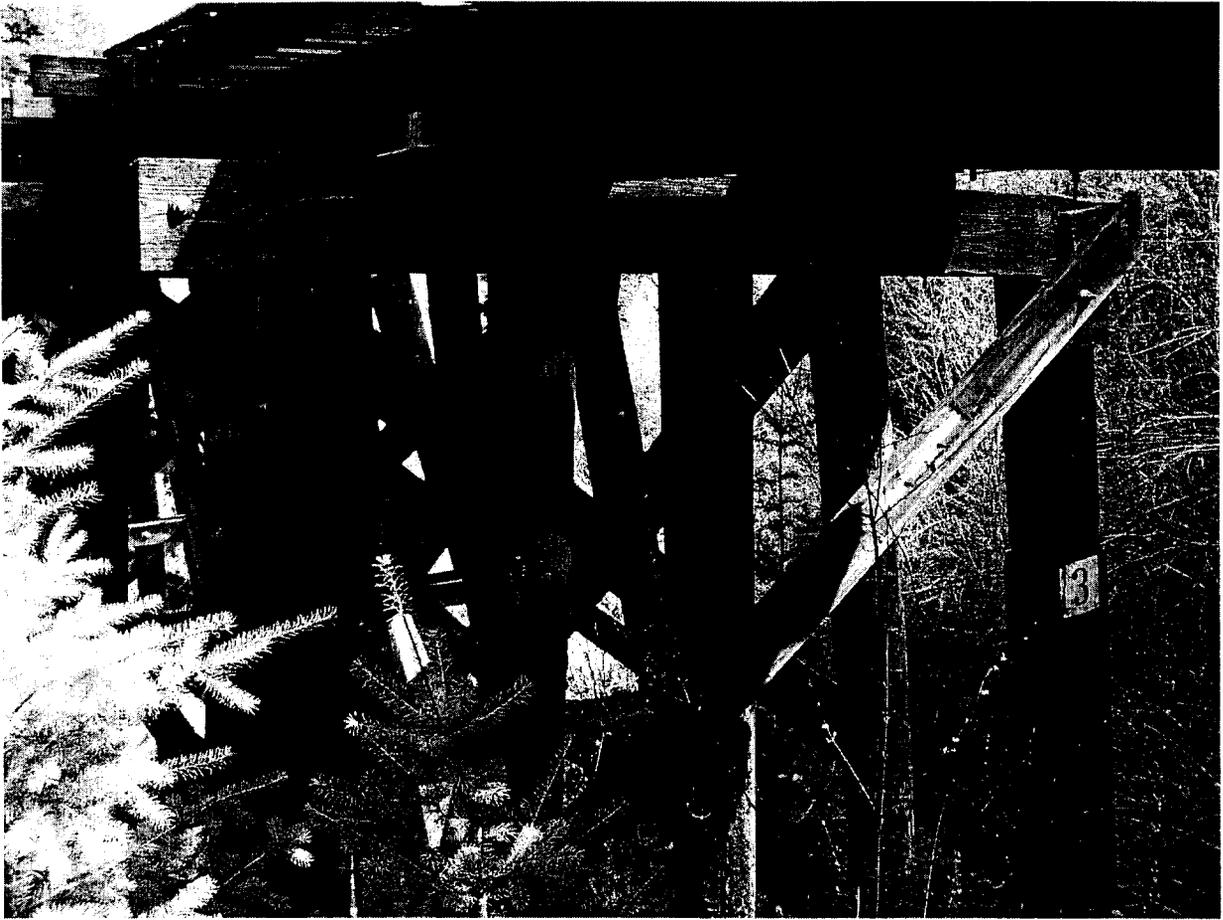
TRESTLE # 17.3

SIDE VIEW

Some trestles have combination stringer / round piling supports.  
This side view shows that combination.

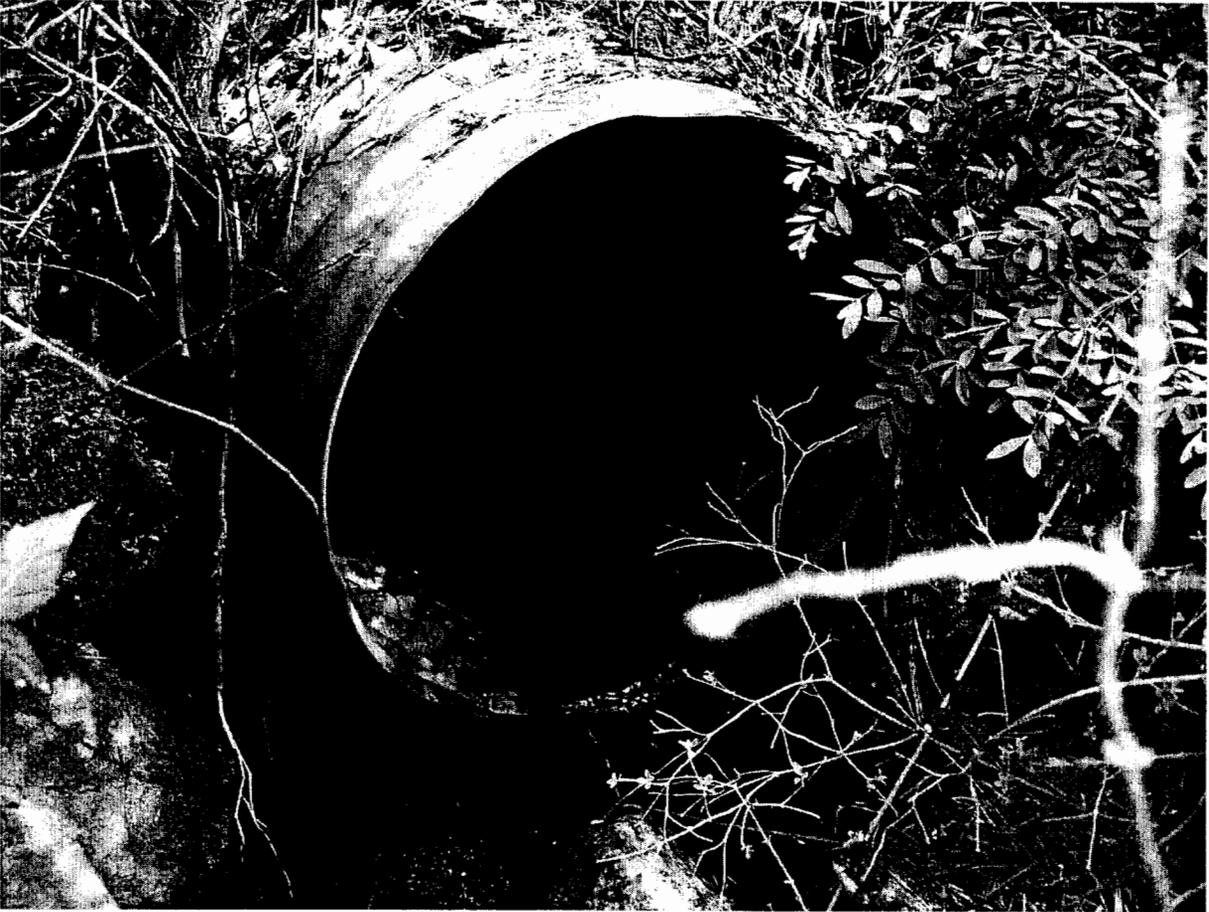
## CULVERT # 10

### INLET

Location SENE Section 36, Township 37 North, Range 4 East.

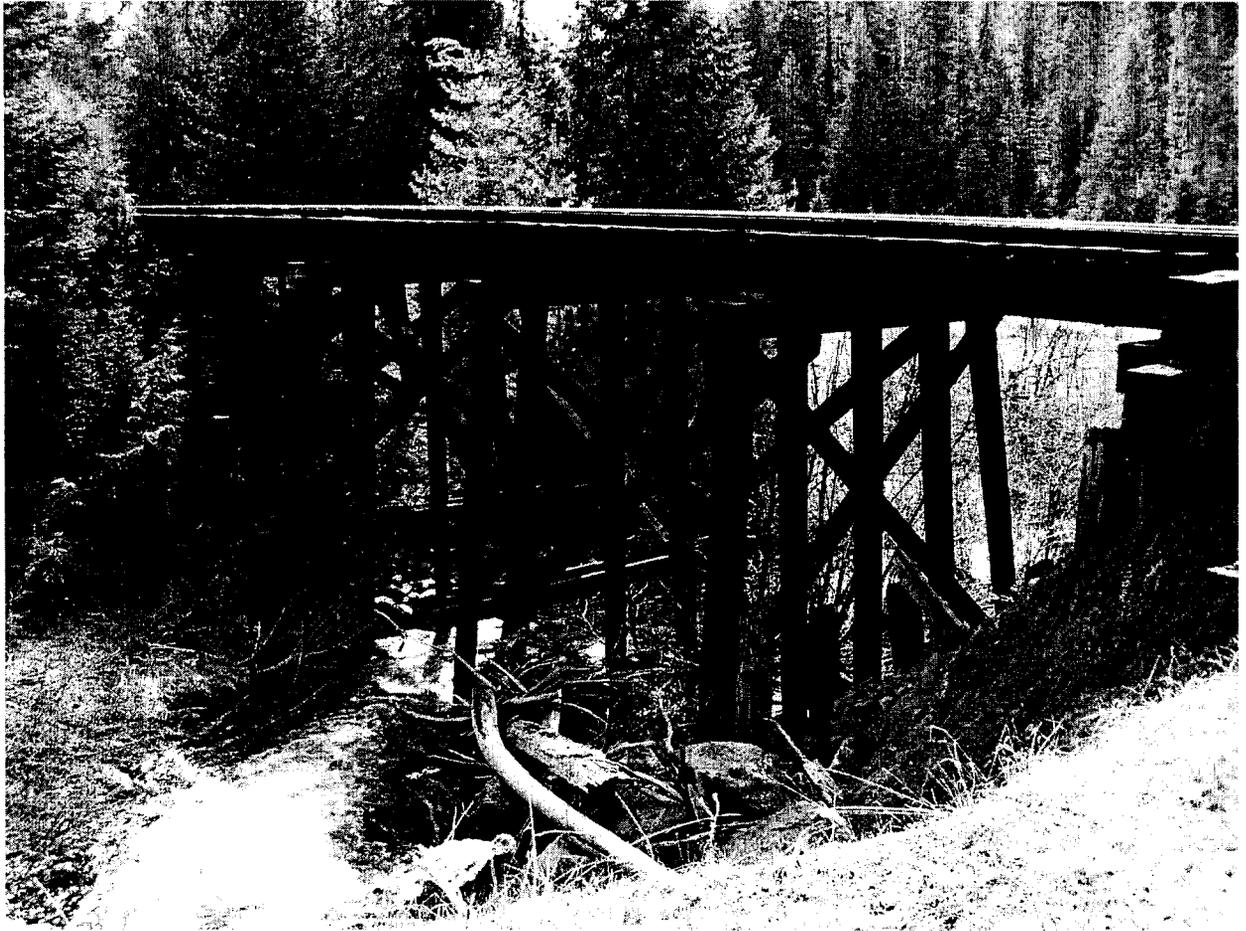
TRESTLE # 21

Trestle 12.3' wide X 75' long, maximum depth to water 21'.

SIDE VIEW

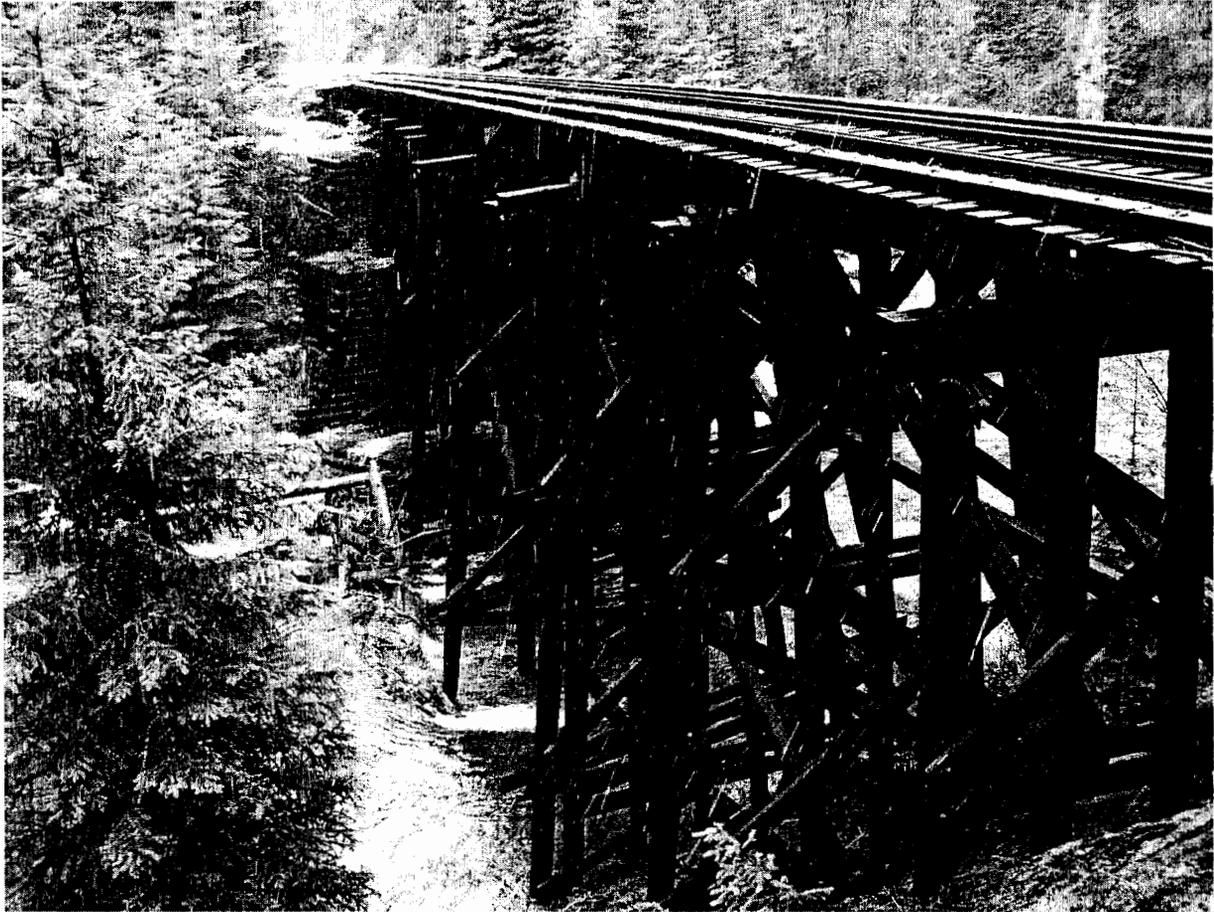
TRESTLE # 24

Straight Trestle 155' Long X 12.3' Wide, Maximum depth to water 34'.

SIDE VIEW

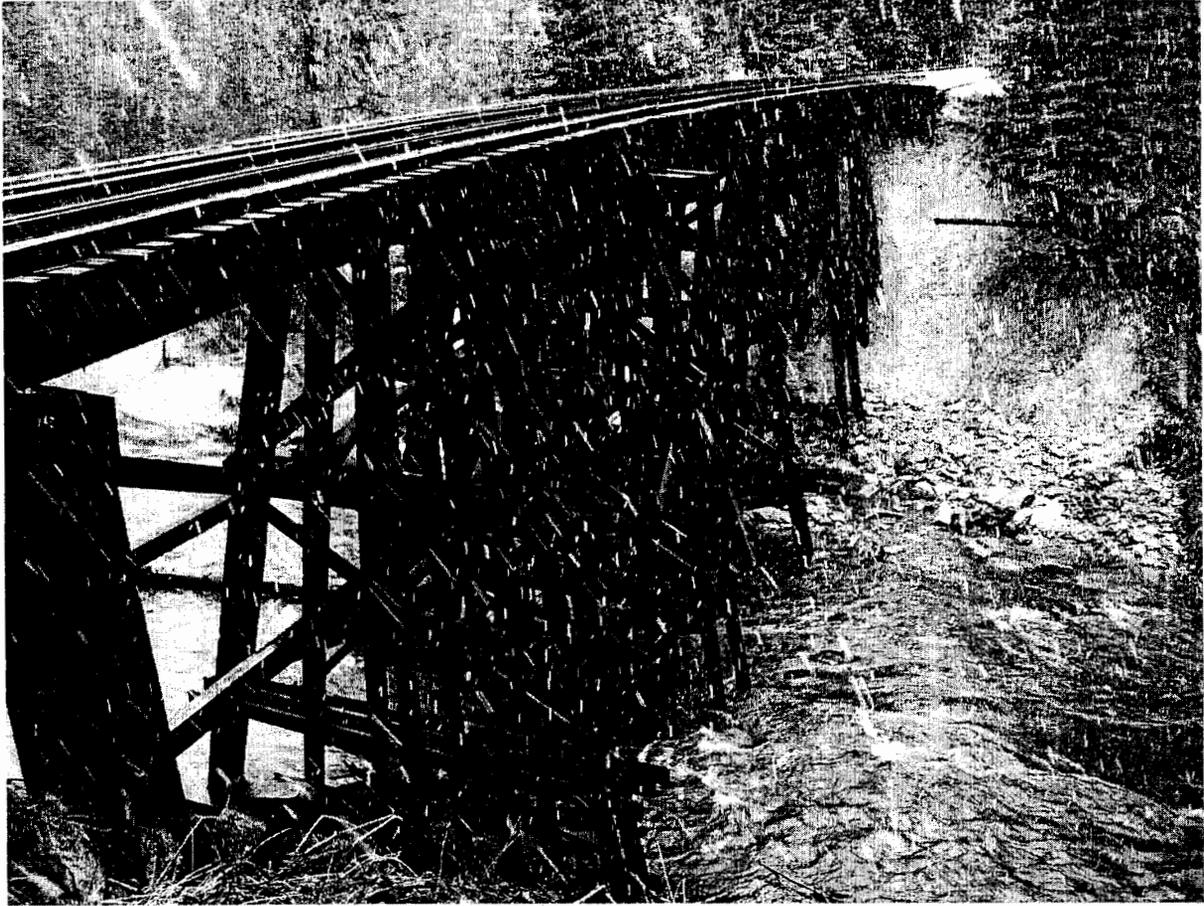
TRESTLE # 24.1 (?)

Curved Trestle 157' Long X 12.3' Wide, Maximum depth to water 34'.  
Crosses Orofino Creek.

SIDE VIEW

NOTE BANK STABILIZATION ON EAST ABUTMENT

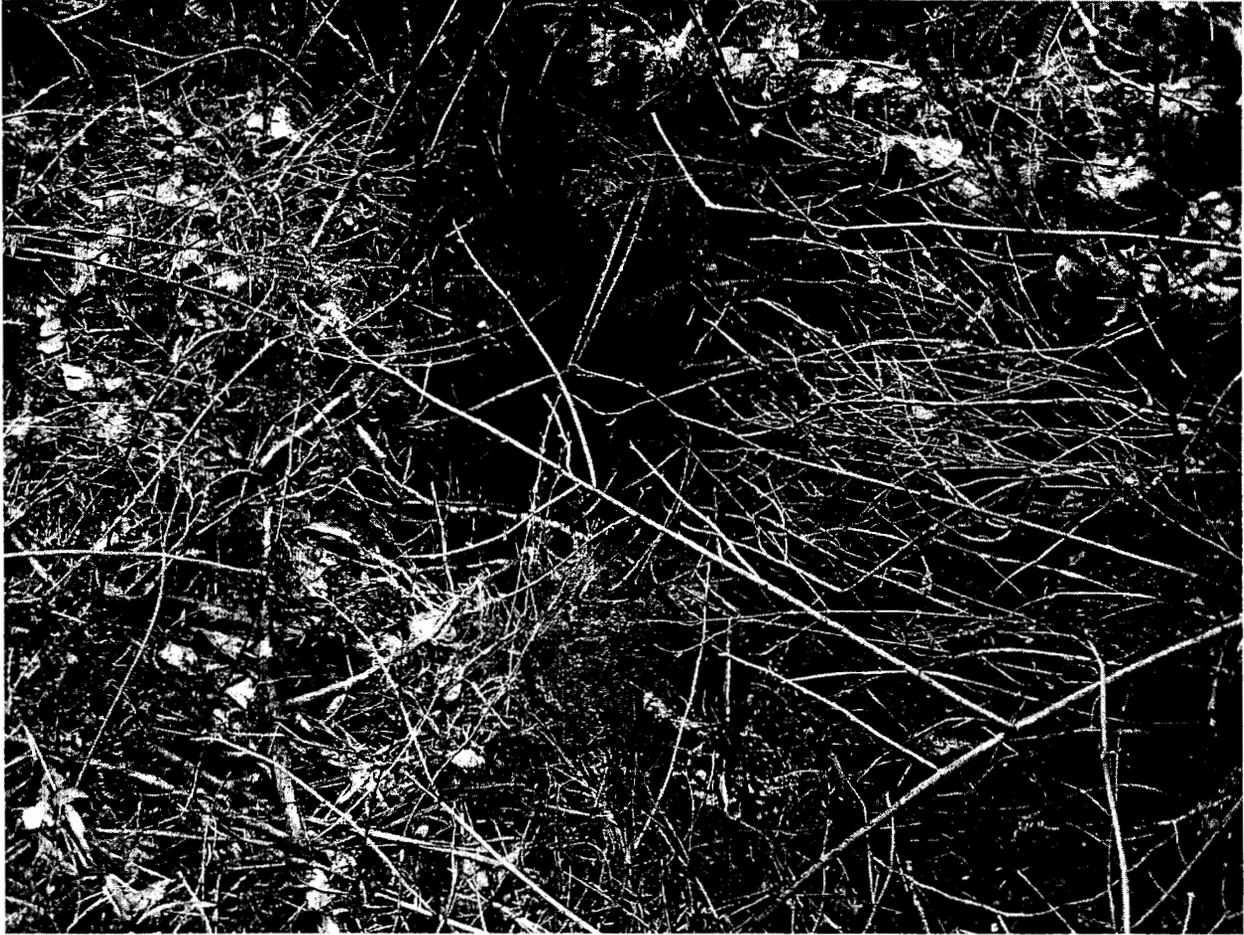
## CULVERT # 11

### INLET

Location SESE Section 33, Township 37 North, Range 5 East.

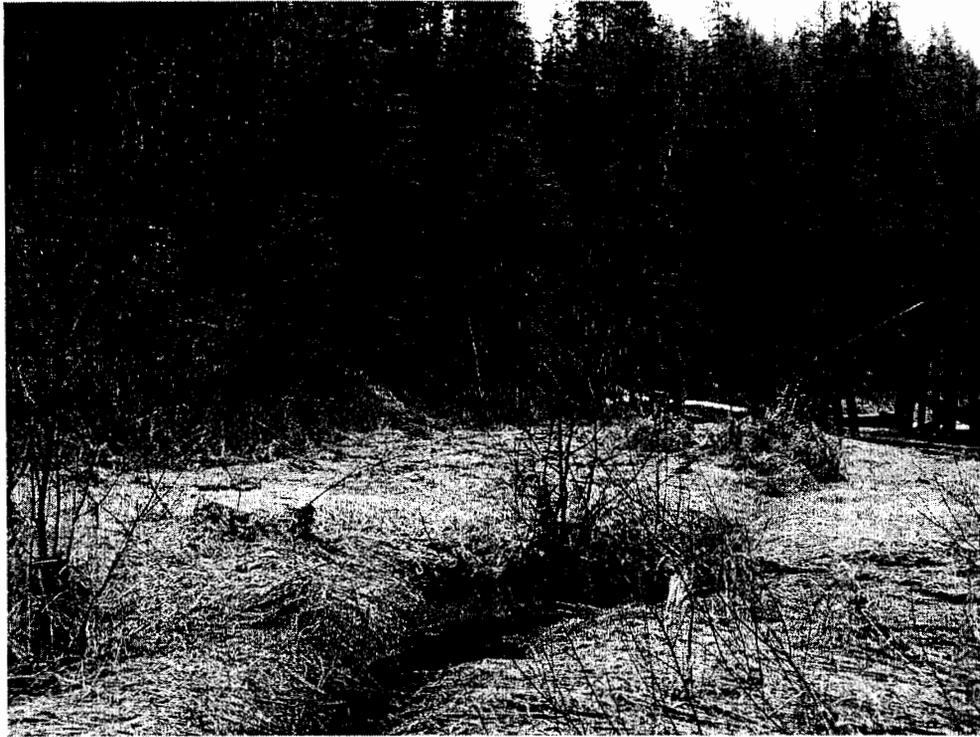
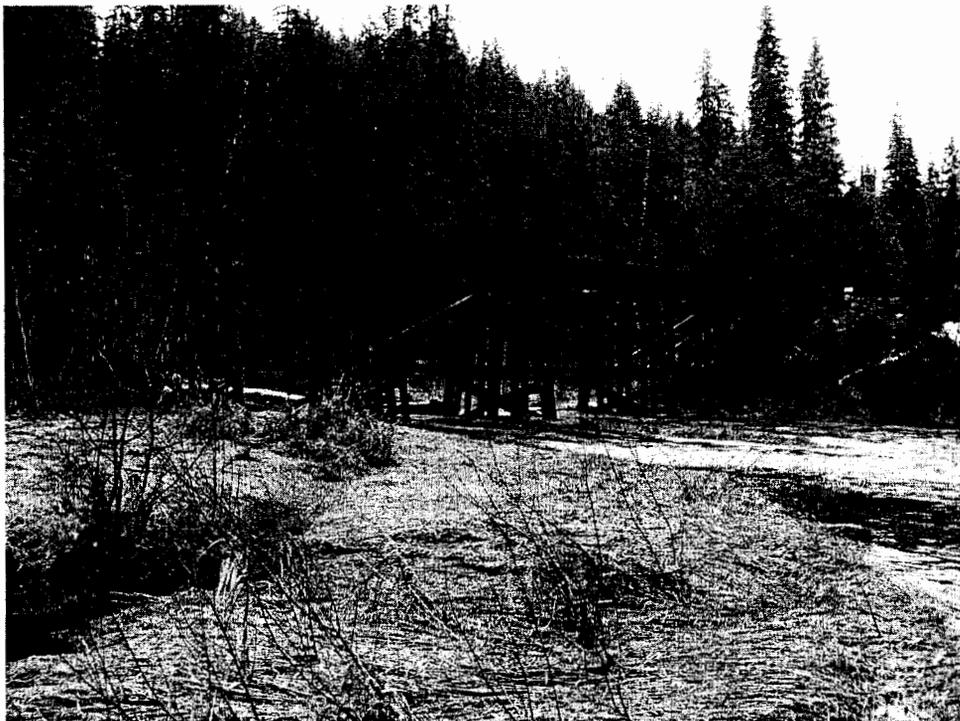
Straight Trestle 168' Long X 12.3' Wide, Maximum depth to water 20.5'.  
Crosses Orofino Creek.

TRESTLE # 25—SIDE VIEW OF WEST AND EAST END OF TRESTLE

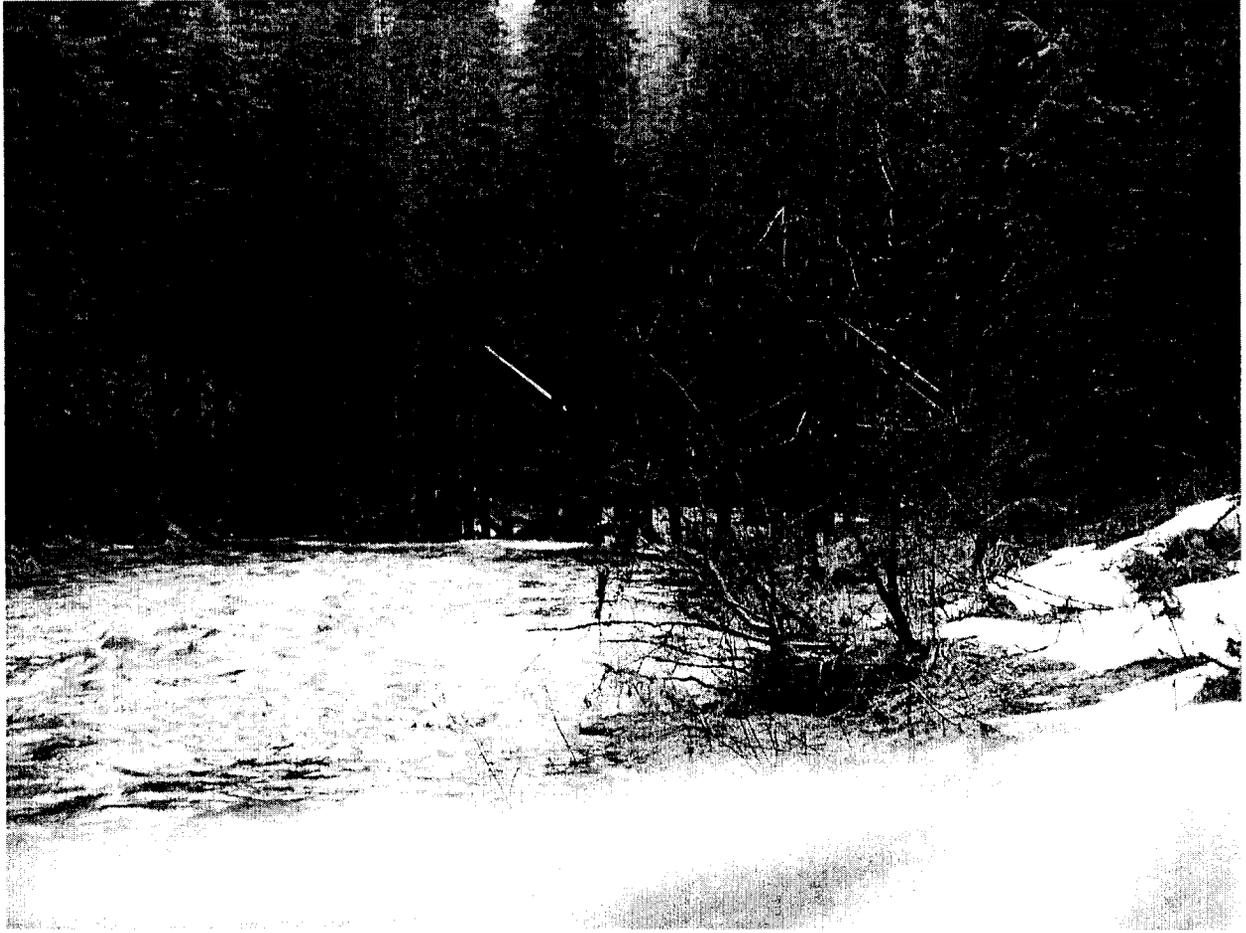
TRESTLE (NO NUMBER)

Curved Trestle 174' Long X 12.3' Wide, Maximum depth to water 23.5'.

SIDE VIEW
